USARTL-TN-29

TESTS TO DETERMINE THE ULLAGE EXPLOSION TOLERANCE OF HELICOPTER FUEL TANKS

Charles M. Pedraini

June 1978

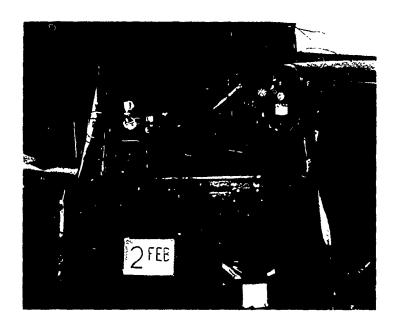
During the third UH-1B test the projectile impacted the right tank, continued through the tank, and expended between the bladder and tank structure of the left fuel tank (Figure 5). The resulting explosion cracked the deck plate and blew it off except for three fasteners, and the fiberglass subpanel failed around its circumference, permitting the bladder to collapse inward about 5 inches. The oval aluminum tank top was bowed and the upper transducer wire was broken. The bladder was torn on three sides around the top of the tank (Figure 8). The pressure transducer near the bottom of the tank indicated a peak of 23.5 psig in 0.22 second.

Figure 8. Aircraft damage resulting from the third UH-1B test.

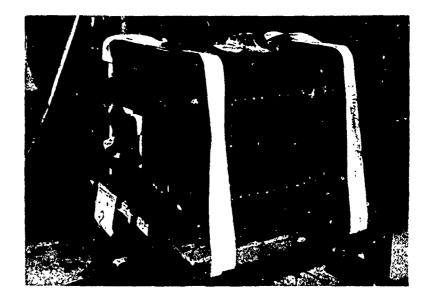
The first two tests were conducted with fuel/air mixtures higher than stoichiometric, resulting in moderate pressure rises that did not cause tank failure. Considerable venting was observed from the top access ports and several windows. The steel flanges were bent slightly during each test. The fuel/air ratio was lowered for the next two tests, resulting in pressure rises that caused catastrophic damage. In test 3 the entire top access port was blown off (see Figure 17), and in test 4 the front of the tank tore across the entire tank width and the escaping gases had enough reactive force to overturn the tank and table (see Figure 18). The tear in this tank, as well as the severe flange bending that also occurred in this test, is shown in Figure 19.

Figure 19. Tank damage resulting from MIL-CUBE test 4.

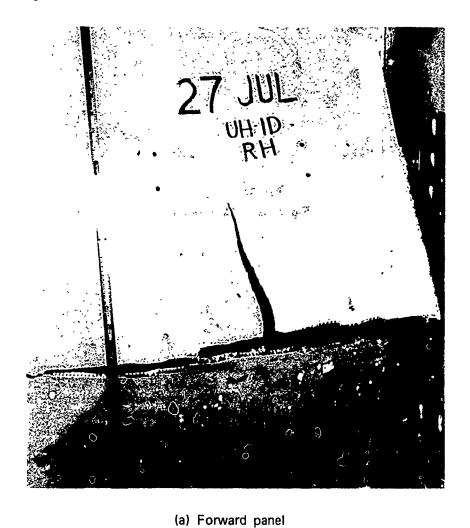
The honeycomb structure on the front and rear of the tank was damaged as shown in Figure 33, but the tank itself was not damaged. The pressure rise was not as high as expected. Since the fore and aft walls of the cavity failed, expansion of the bladder could have reduced the pressure. Also, some pressure relief occurred through the vent.

Figure 33. Damage to upper-right UH-1H tank structure.

(b) Aft panel Figure 33. Continued.
